Site Visit Re

Date: Client: **Project:** February 16, 2017 **Grafton Planning Board**

Gristmill Village

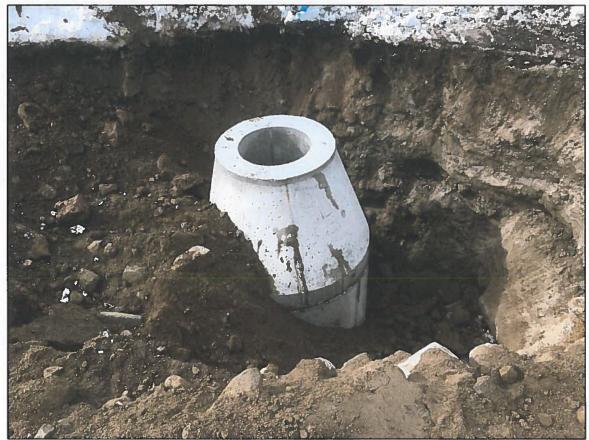
Upon my arrival to the site, DiPilato Construction was backfilling DMH-7 with sorted trench spoil and compacting with a vibratory plate compactor. The section of installed drain pipe listed above had been backfilled prior to my arrival. The pipe penetration into DMH-7 was mortared. No invert channel was constructed in the base piece of DMH-7. I was informed by DiPilato that the inverts would be constructed in the rest of the manholes after complete drainage installation.

Photo 1: Installed and partially backfilled DMH-7.
